*This brief case study presents the challenges of performing a U-value measurement on a roof and the precautions and steps to overcome them. The challenges of measuring a very low U-value and the corresponding measurement quality assessment methods are also discussed. A potential solution, in the form of a U-value calculation algorithm, is then proposed to faster achieve ISO 9869 conformity.*

### **U-Value Measurements at the Roof of an Indoor Swimming Pool**

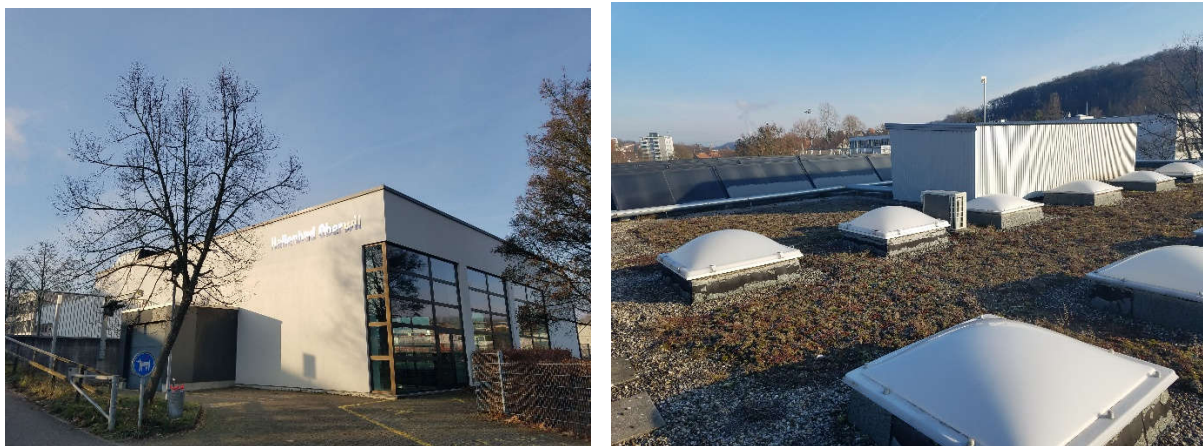
Figure 1 Indoor swimming pool at a glance (left) and skylights on the building roof (right)

As seen in Figure 1, the roof of the building is covered with skylights. Using infra-red thermal imaging, it was easily established that these skylights were a great source of thermal leakage due to poor conductive insulation. Additionally, a quick inspection of the skylight's simple fasteners indicated that air leakage were also a highly likely source of thermal leakage. However, the U-values of the skylights were not assessed as they only represented a small surface area of the whole roof. Instead the U-value measurements were taken on the standard roof structure, but not over the swimming area. This was because the ceiling over the swimming area was too inaccessible and impractical to reach. The locations and serial number pairings of each node are shown in Figure 2.

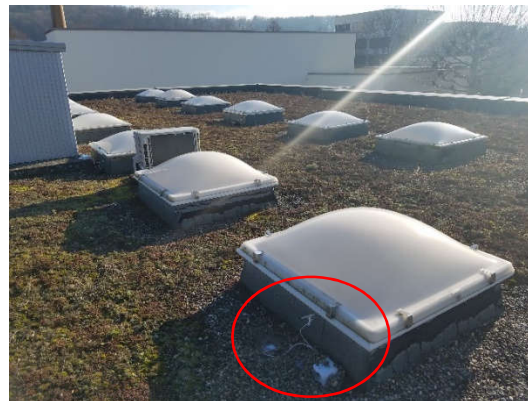
Another significant challenge of taking U-value measurements on the roof was the exposure to solar radiation. Taking advantage of the sun's low solar angle during winter time, the sensors were placed in the north-side of each skylight to minimise solar radiation effects on the outside temperature sensors as can be seen in Figure 3.

Figure 3 Nodes placed on the north-facing side of the skylight to avoid radiation exposure

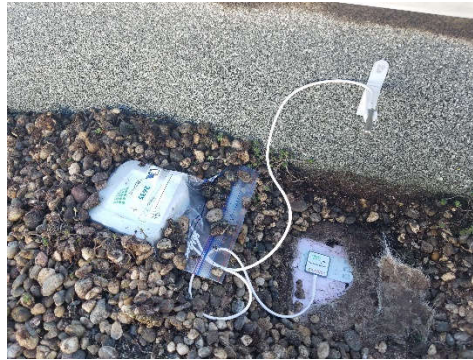
Since the measurements were performed on a flat surface and weather forecasts predicted heavy snowfall for two consecutive days after the measurement start, there was some concern about water ingress into the gOMS electronics. (The gOMS is IP44 weatherproof and splash proof, but is not designed to withstand submersion or prolonged water exposure.) A simple but effective solution was devised: each measurement node was placed into a Ziploc-like plastic bag, but not fully sealed, to allow the node cables and sensors out of the plastic bag. This is seen in Figure 4.

Figure 4 Protecting nodes from water ingress using Ziploc-like plastic bags and removing gravel until a flat and clean surface was reached

Another measurement setup challenge was the presence of loose gravel on the roof which prevented outdoor surface temperature sensors from being mounted directly. The gravel was removed until a flat surface was reached, which was then cleaned before the sensors were mounted onto it. It should be noted that these steps to mount the outdoor surface temperature sensor are unnecessary if R-value measurements are not required. (U-value measurements only require heat flux and ambient temperature measurement inputs, not surface temperature)
