U-Value and Mold Measurement – Potential and Technical Feasibility of Renovation of Listed Heritage Buildings

This case study reports U-value and a_w -value measurements carried out on a listed historic building in Switzerland. The aim was to determine the minimum insulation required for renovation and examine the risk of mold growth in the basement. All necessary measurements were conducted with the gO-Measurement System from greenTEG and a thermal imaging camera.

The present case concerns a 16th century mansion in Schwyz, Switzerland (<https://www.immenfeld.com/>). The owner intended to restore the home to rent out the premises for events and the following questions arose:

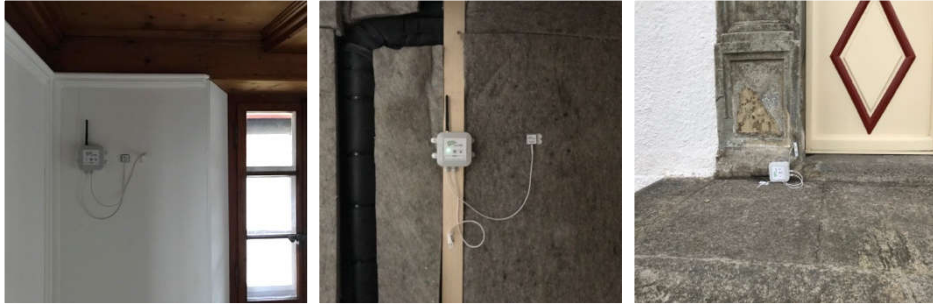
As described above, the building U-values were measured on an insulated and an uninsulated wall. Additional humidity and dew point measurements were taken in the basement. For the U-value measurements, one Type 1 Measurement Node was attached to the interior side of each wall to measure heat flow and interior temperature. A Type 2 Measurement Node was installed on the exterior side of the wall, which measured the outside surface and ambient air temperature over the measurement period. All three measurement nodes are shown in Figure 3-1.

Figure 3-1: Type 1 measurement nodes on the uninsulated wall (left), Type 1 measurement nodes on the insulated wall (centre) and Type 2 measurement nodes outside (right)

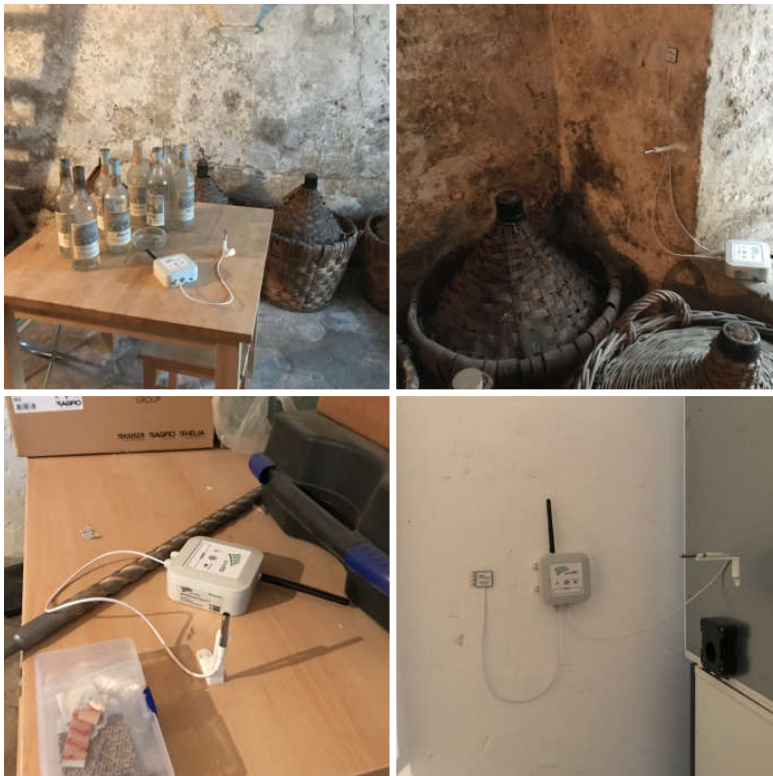
The relative humidity and a_w were measured in two different basement rooms. A Type 3 Measurement Node was installed to measure relative humidity in the middle of the room, while a Type 2 Measurement Node was installed to measure surface temperature at a critical point of the wall. The four measurement nodes are shown in Figure 3-2.

Figure 3-2: Type 3 Measurement Nodes for measuring relative humidity (top & bottom left) and Type 2 Measurement Nodes for measuring wall temperature (top & bottom right)

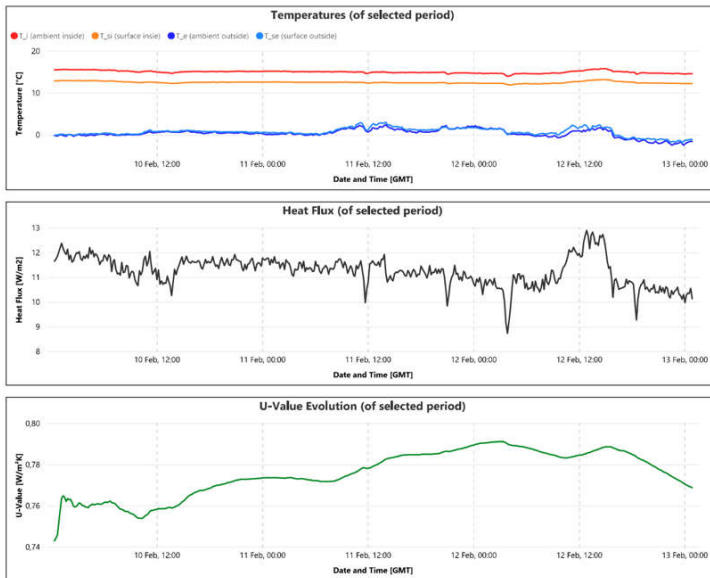
The U-value measurement on the un-insulated wall took place between 10 February 2018 and 13 February 2018. The measurement results are shown in Figure 4-1. The meteorological conditions were very constant during the measuring period and with a constant temperature difference of approximately 20°C, which is ideal for a U-value measurement. The measured U-value is $0.77 \frac{W}{m^2 \cdot K}$, which was better than expected.

Figure 4.1-1: U-value measurement data of the uninsulated wall

To meet cantonal requirements to qualify for subsidies, refurbished walls may have a maximum U-value (U_{max}) of $0.3 \frac{W}{m^2 \cdot K}$. Sheep wool was chosen as the insulation material, which has a λ -value of $0.04 \frac{W}{m \cdot K}$ ($\lambda_{sheep\ wool}$). From this the required insulation thickness ($d_{sheep\ wool}$) can be calculated as follows:

$$U_{max} = \frac{1}{\frac{1}{U_{wall}} + \frac{d_{sheep\ wool}}{\lambda_{sheep\ wool}}}$$

$$d_{sheep\ wool} = \left(\frac{1}{U_{max}} - \frac{1}{U_{wall}} \right) \cdot \lambda_{sheepwool} = \left(\frac{1}{0.3 \frac{W}{m^2 \cdot K}} - \frac{1}{0.77 \frac{W}{m^2 \cdot K}} \right) \cdot 0.04 \frac{W}{m \cdot K} = 0.08m$$

The required insulation thickness for this wall is therefore 8 cm, which is well below the 16 cm recommended by the expert.

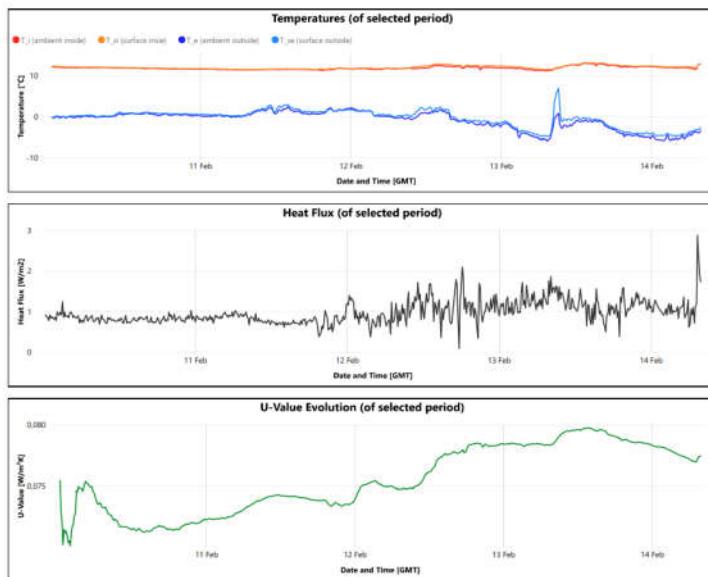
The measurements on the already renovated and insulated wall (with 16 cm sheep's wool), took place at the same time as the measurements on the un-insulated wall. So the same ideal measuring conditions prevailed. The measurement results are shown in Figure 4-2. The measured U-value was $0.078 \frac{W}{m^2 \cdot K}$. It is thus significantly less than the calculated U-value of $0.19 \frac{W}{m^2 \cdot K}$ (based on the formula above). The most likely reason for this is that the refurbished wall does not have the same construction/thickness as the un-insulated wall, thus making it better insulated.

Figure 4-2: U-value measurement data of the insulated wall

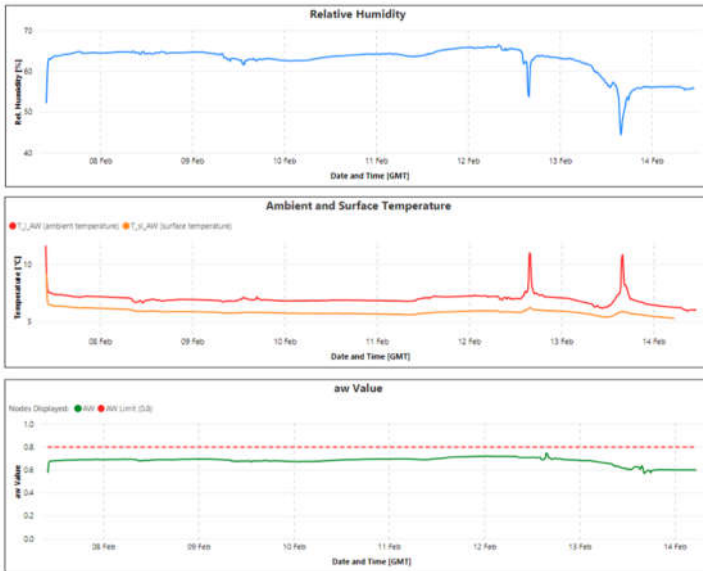
Figure 4-3: Measurement data from Cellar Room 1

The measurement data of Cellar Room 1 (see Figure 3-2 above) can be taken from Figure 4-3. The relative air humidity was constant with approx. 65% over the measured period. The room temperature was approximately 7.5 °C and the wall temperature was approximately 6.5°C. The relative humidity was constant over the measured period. The a_w -value calculated was on average around 0.7 and thus just under the critical limit of 0.8.

Since the a_w -values are just slightly less than the critical limit in both rooms, in principle, one can say that there is a risk of mold formation. Since the risk of mold formation for old buildings tends to be higher in the summer, the measurements should be repeated then. In addition, it is also useful to regularly check the humidity in the rooms and, if necessary, use a dehumidifier.

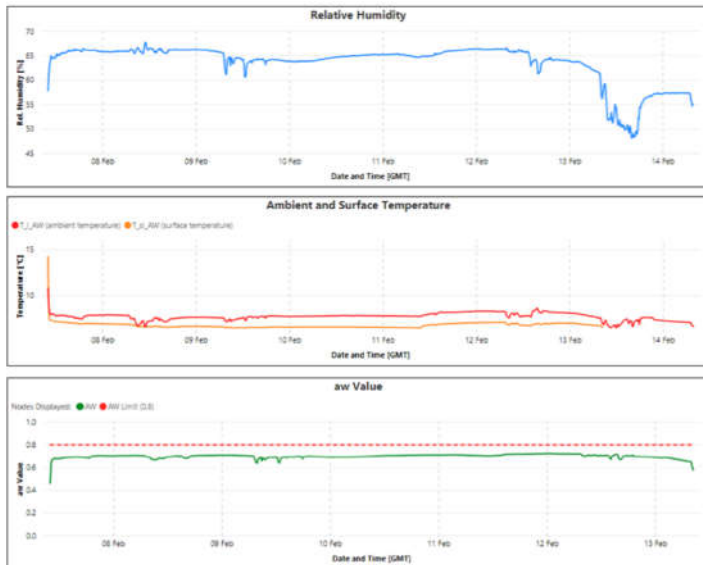
Figure 4-4: Measurement data from Cellar Room 2

The measurements in Cellar Room 2 (see Figure 4-4 below) are visible in Figure 4-4. The measurement results are similar to those in Cellar Room 1. The air humidity was approximately 65%, room temperature approximately 7 °C and the wall temperature approximately 6.5°C. The calculated a_w -value similarly fluctuated around 0.7.
